INSPECTION REPORT

Museum Collections: Preservation and Protection Issues with Collections Maintained by the National Park Service

Subject: Inspection Report – Museum Collections: Preservation and Protection Issues with Collections Maintained by the National Park Service (C-IS-NPS-0008-2010)

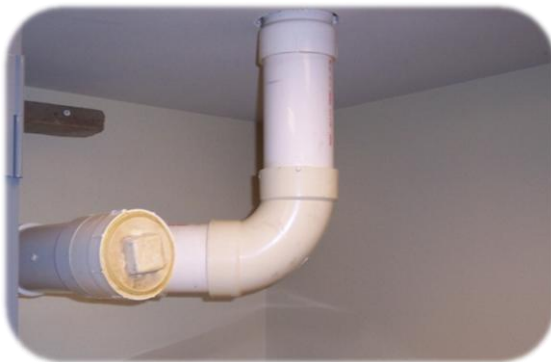
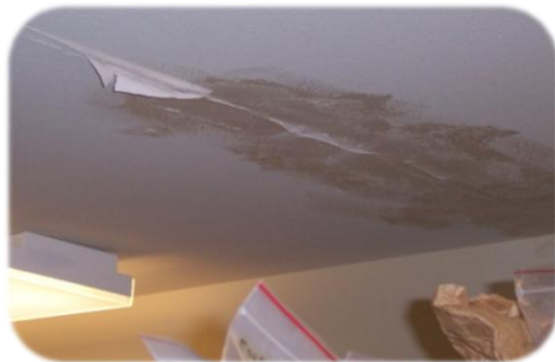
- **Storage space was not safe from flooding.** For example, at the Fort Union Trading Post National Historic Site in Williston, ND we observed water pipes running directly over the museum property storage cabinets that were not waterproof. In addition, there was evidence of past ceiling water damage in another storage area.

Recommendation 1. Correct and/or mitigate, to the greatest extent possible, all identified deficiencies at the seven sites identified in this report.

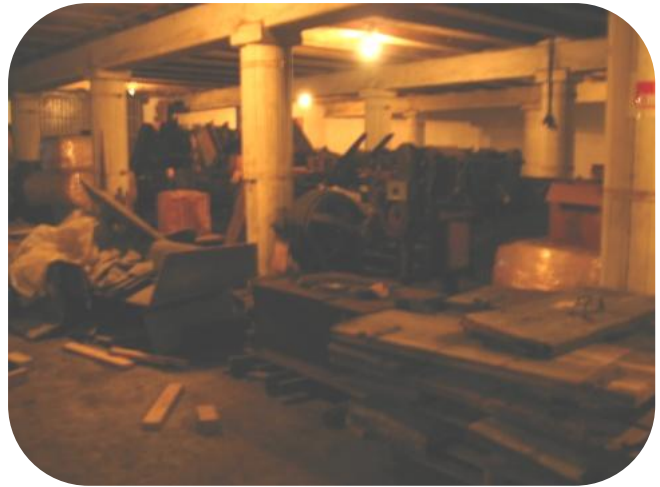
- **Museum property was not safeguarded from overcrowding, breakage, or cross-contamination.** For example, at the Boston National Historic Park in Charlestown, MA we observed one dimly lit, cluttered, and disorganized storage room which contained various large historic items. Items continued to be added to the room despite open space available elsewhere. In another location, items such as antique furniture, carts, and bicycles were stacked on top of each other or were leaning against one another without protection.

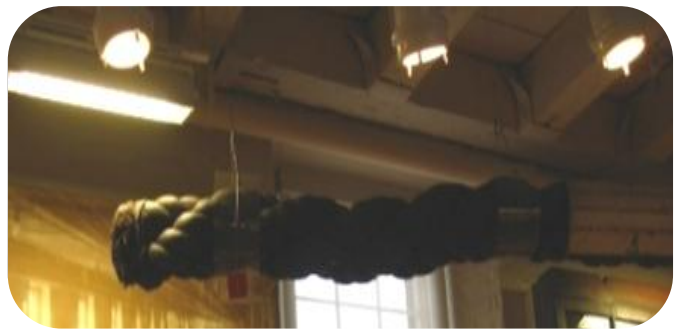
- **Light not appropriately controlled resulting in potential damage to museum property.** For example, at the Boston National Historic Park in Charlestown, MA the museum curator acknowledged that the visitor's center needs to be re-lighted because lights used in the visitor's center are inappropriate for the artifacts. For example, an old ship rope was displayed directly under track lighting, leading to the potential for premature deterioration.

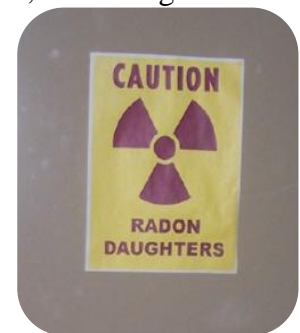
- **Museum property was not safeguarded against fire.** For example, at the Hagerman Fossil Beds National Monument in Hagerman, ID we observed the lack of fire detection and suppression systems despite having radioactive material present.¹ Additionally, at the Arlington House in Arlington, VA we observed that neither the museum nor the site's annex had fire detection or suppression systems that housed paintings, furniture, books and textiles. Fire suppression had been slated to be installed in the museum building in FY 2006; however, this did not occur.
